# Fast Curing, Surface Tolerant, Abrasion Resistant System for Patch Repairs

Belzona 1818 is a fast curing, surface tolerant, abrasion resistant system ideal for patch repairs on surfaces subject to high erosion and abrasive environments.

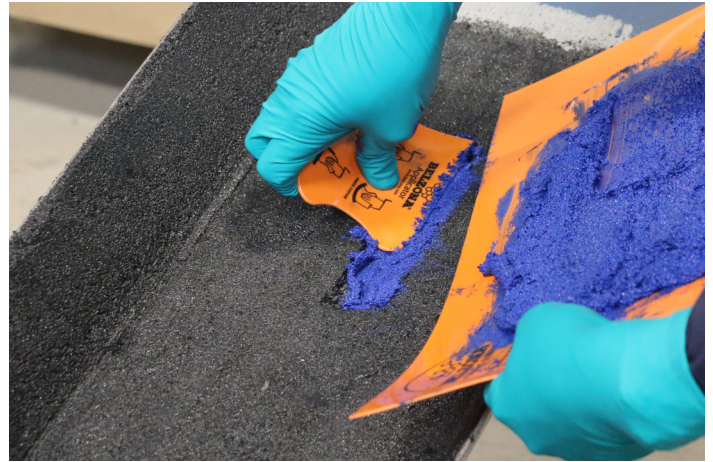
As shown in the image above, Belzona 1818 is ideally suited for patch repairs where a rapid return to service is required.
