BELZONA[®]
GREAT LAKES

**HVAC
COOLING TOWER
COLD BONDING**

COOLING TOWER
APRIL, 2019

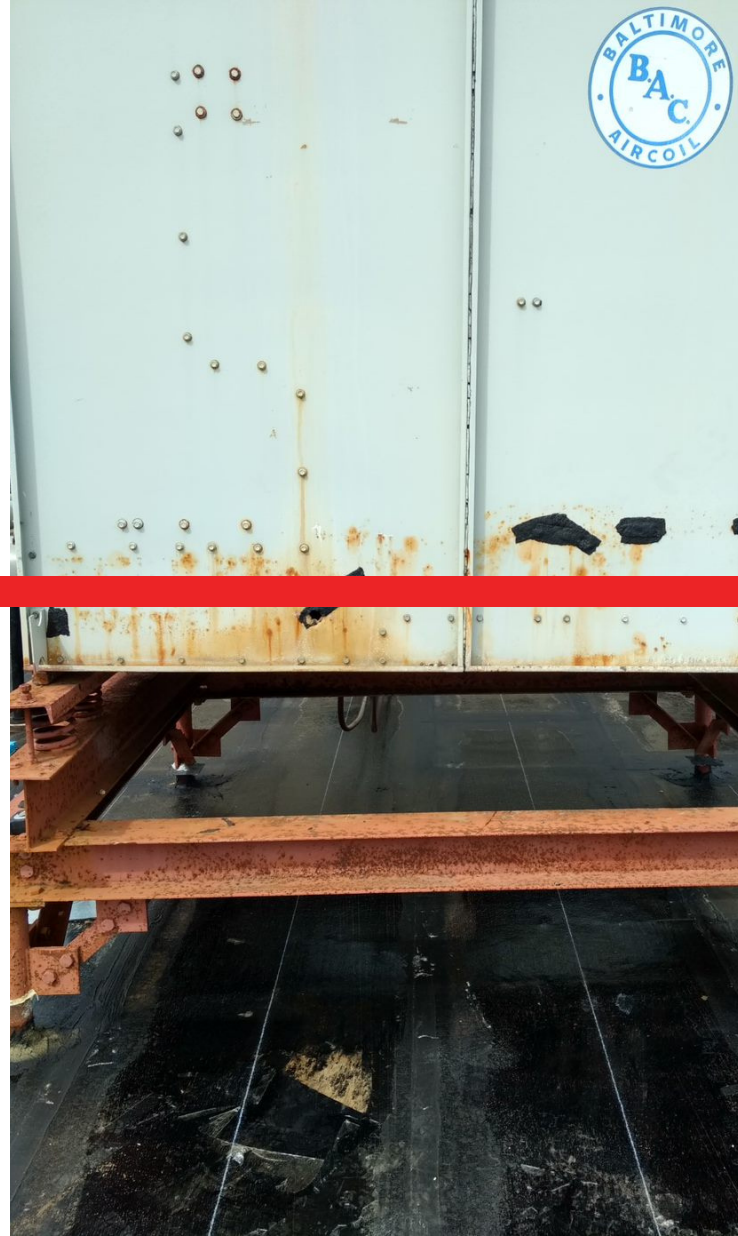
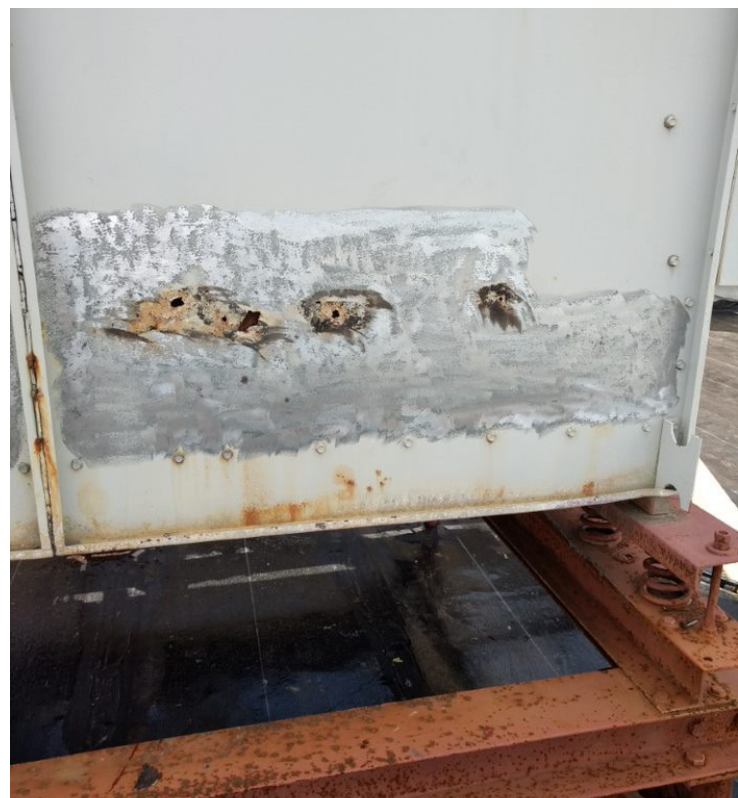
A company in Central Ontario was having problems with their cooling tower. The equipment was experiencing corrosion and in some areas they even had through wall defects.

The customer wanted to seal the holes in the equipment to prevent further deterioration. They did not want to weld as they knew that welding would require specialized equipment, hot work and post-welding treatment to revert metallurgical changes caused by welding.

We showed the advantages of our Belzona cold bonding solution and the customer decided to proceed with it.

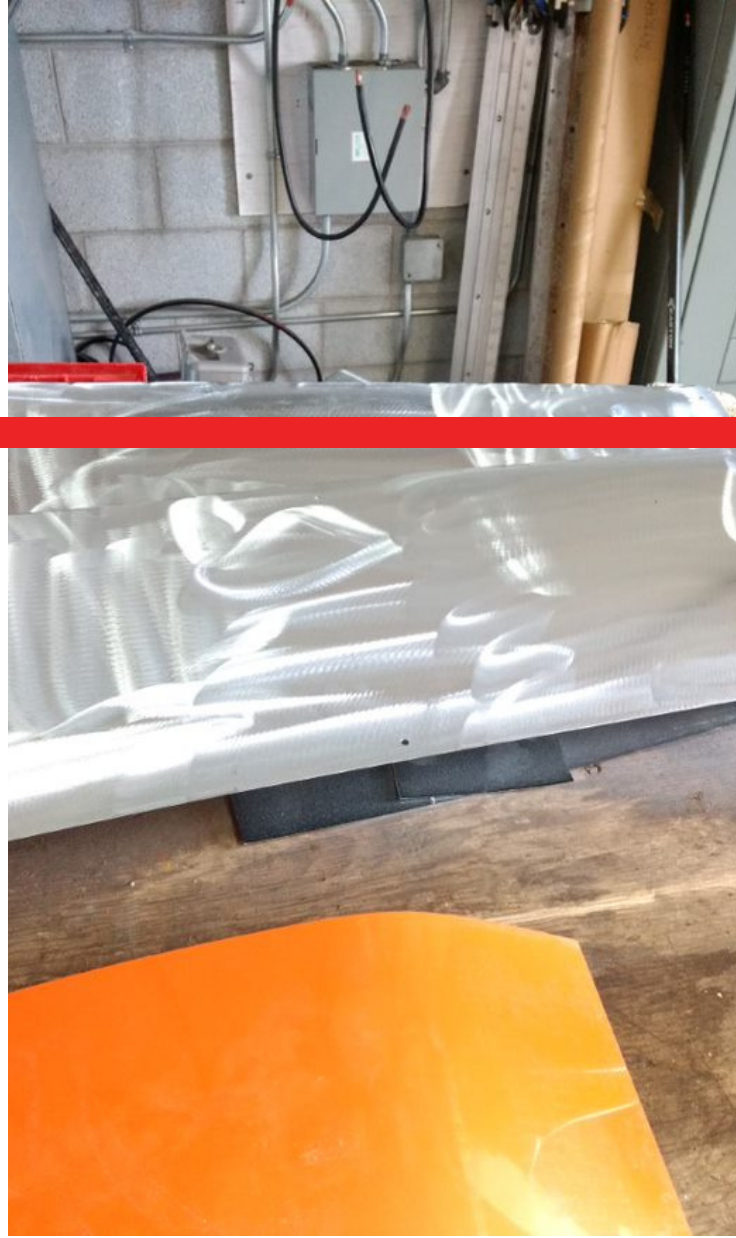
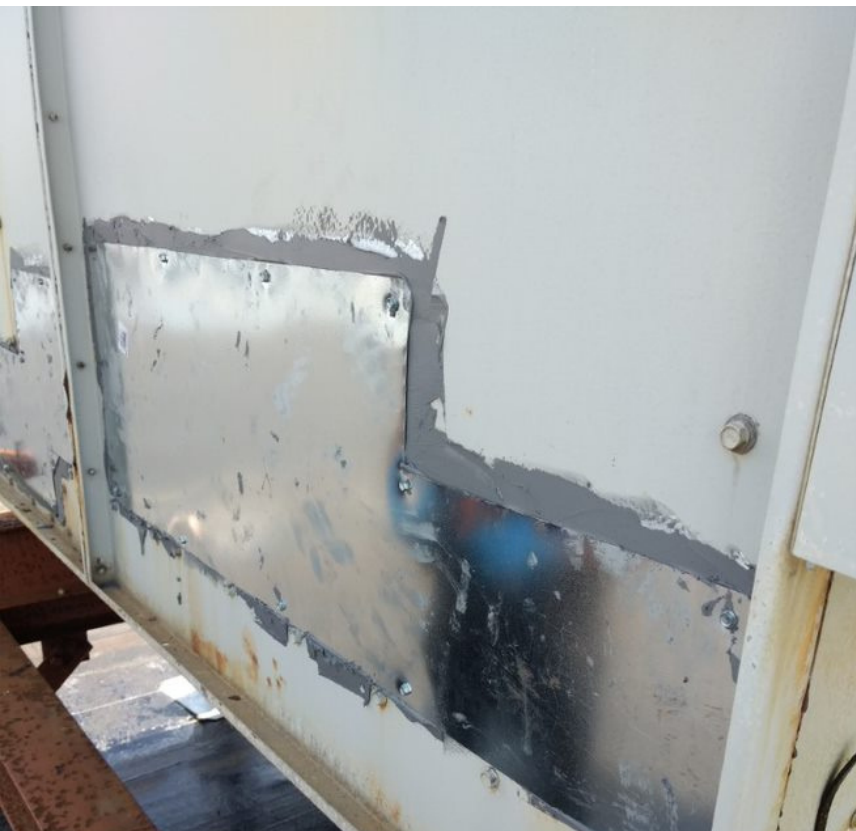
Patch plates were pre-designed to fit the damaged area. The surface of the weakened substrate and underside of the plate were cleaned and abraded to create a mechanical profile. Belzona 1111 (Super Metal) was mixed and applied over the damaged area and on the underside of patch plate, making sure the material was wetting out the profile as much as possible.

The metal plate was then forced onto the weakened substrate. Excess material exuding from the edges was removed and chamfered around the perimeter of the plate.

Belzona 1111 (Super Metal) was specified as the cold bonding material. This product is a cold curing 100% solids epoxy that can be used as a high strength structural adhesive.

Belzona 1111 (Super Metal) is a paste grade 100% solid epoxy material. The product can be used for multiple purposes such as bonding, shimming, rebuilding, wrapping, patching to name a few. The product will not shrink while curing, so it allows to achieve exact dimensions and geometries when necessary.
